NUMBER 17

DATE: 7-9-59

GENERATOR MOUNTING BRACKET ALIGNMENT

1958-59 Lincoln
and Continental

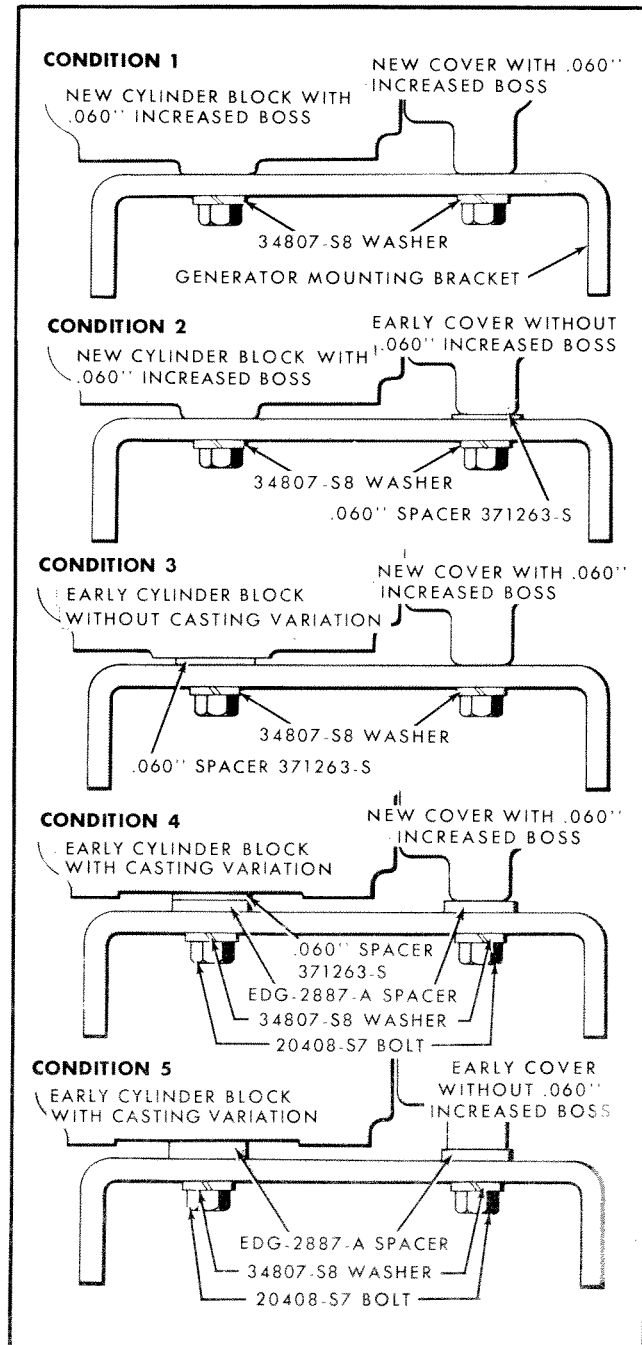
Fig. 1 - Generator Mounting Bracket Installation Conditions

New cylinder blocks and cylinder block front covers are being used which have .060" increased height at the generator mounting bracket bosses. The increase in boss height has been added to eliminate any block casting variations or improper machine boring which could cause misalignment and subsequent generator bearing or belt failure.

The new parts can be used in any combination with the early type parts providing they are used in conjunction with the necessary spacers and washers as shown in figure 1.

If a mounting bracket is found misaligned, distorted or broken on an engine not having the increased boss height, install a new bracket with the spacers, washers and bolts as shown under condition number 4 or 5 in figure 1.
